G100UL Usage Report

Bonanza A36, N4305U, manufactured 2000, s/n E-3305

2025 04 02, version 6

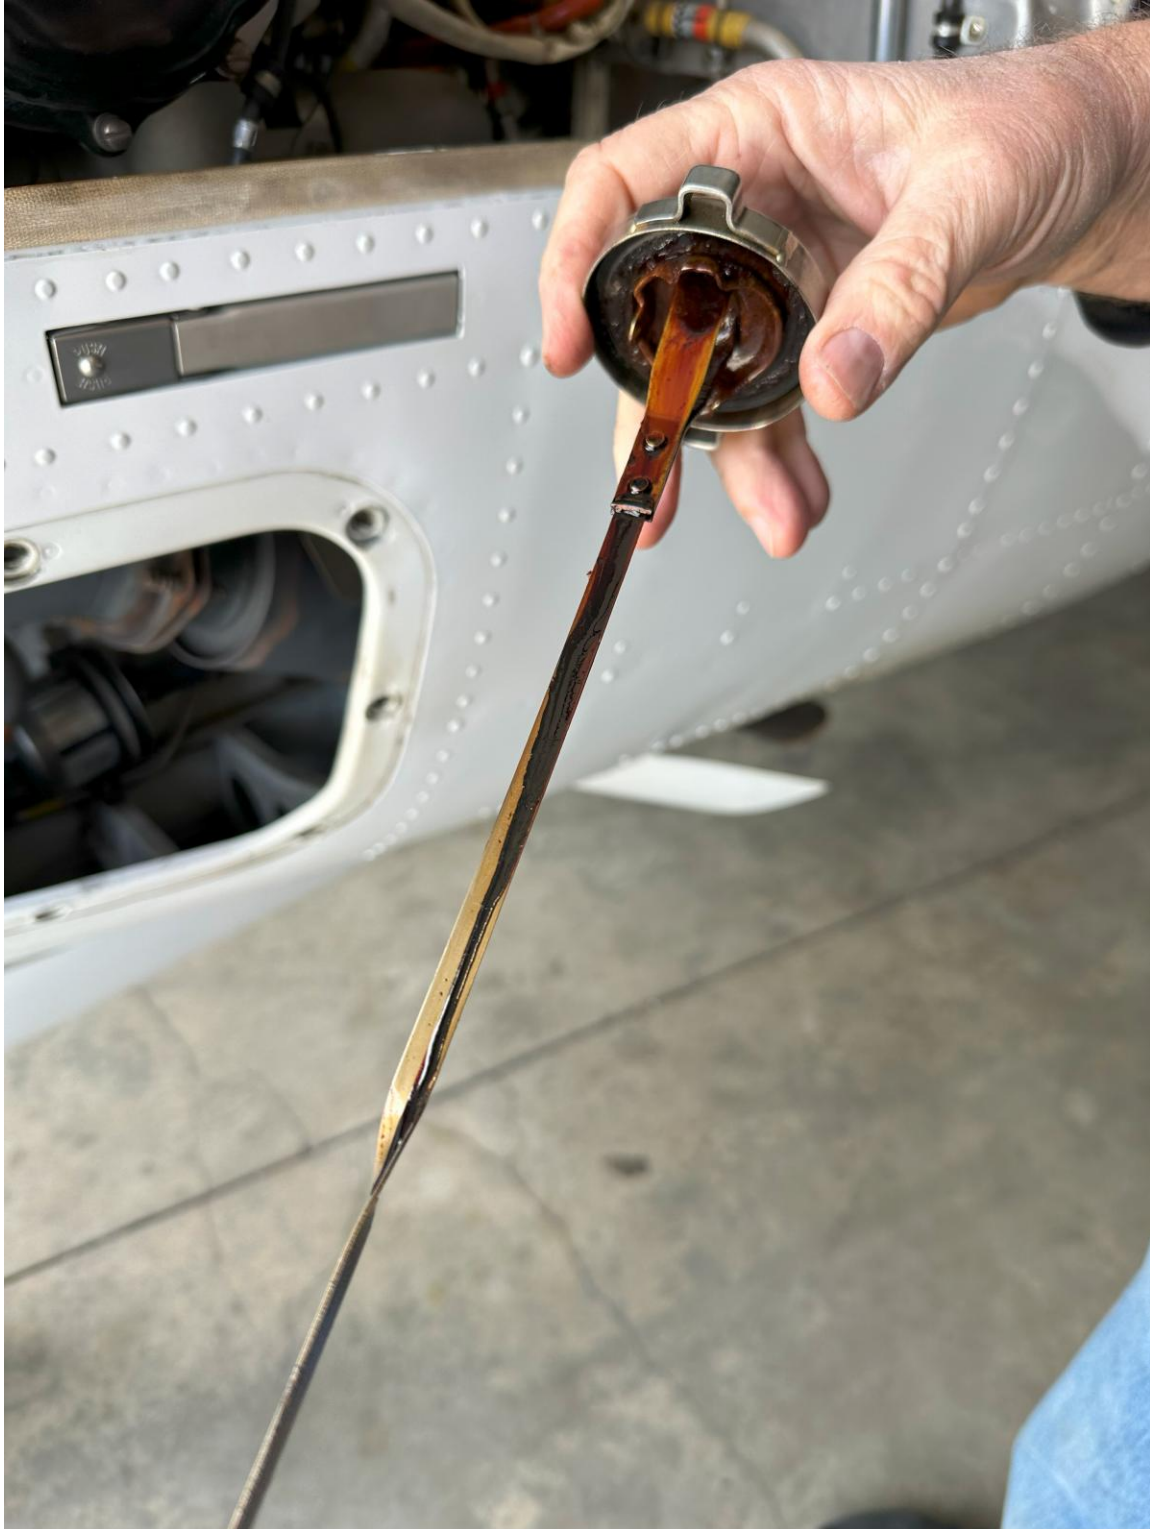
- c. I have noticed varnish deposits on my oil dipstick, rubbery substances at the top of the dipstick and cap, and an increased friction of the dipstick/cap assembly when removing it or installing it in the engine. Previously, there was only motor oil and a few drops of water at these points and no friction. I note also that the two oil changes I performed on my plane (see attached oil analysis) showed slightly lower viscosity of my Philips X/C 20W-50 motor oil after relatively short oil change intervals. These observations give me concern that G100UL is attacking the chemistry of the lubrication in my engine, or that blowby of foreign substances in the combustion chamber is changing the chemistry of the oil, or causing deposits in the engine that may impair engine performance or reliability.

There was hard shiny black matter running down my dipstick, baked on, thickest at the top of the stick. The mechanic said it cleaned up easily at the annual with solvent. I used to see only oil and sometimes a little condensed water on the dipstick. This photo was taken during the annual, before the mechanic cleaned off the dipstick, cap, and mounting socket. I believe he said mineral spirits were sufficient to remove the black varnish on the dipstick.

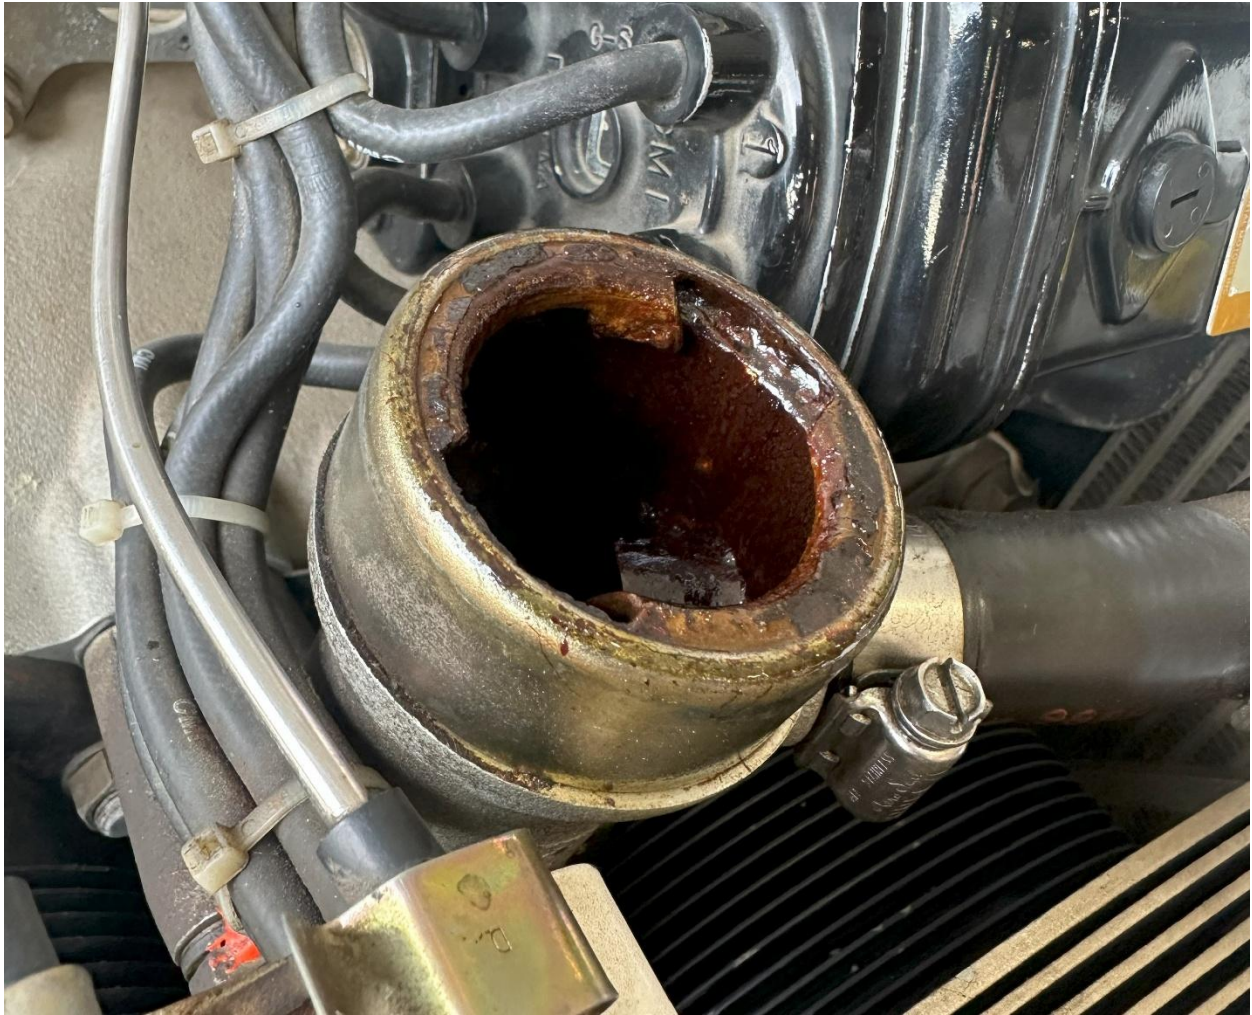
This is where the dipstick and cover assembly is installed in the engine. At one time close to the time of the annual I also saw some small rubbery pinkish pellets, maybe 1/16" in diameter, but I didn't think to take a picture at the time. Normally all I see here is oil and perhaps some water. Based on these disturbing observations, I had the shop change my oil 4 weeks before the annual. Normally I change my oil on 50-hour intervals, but this change came at 29.6 hours.

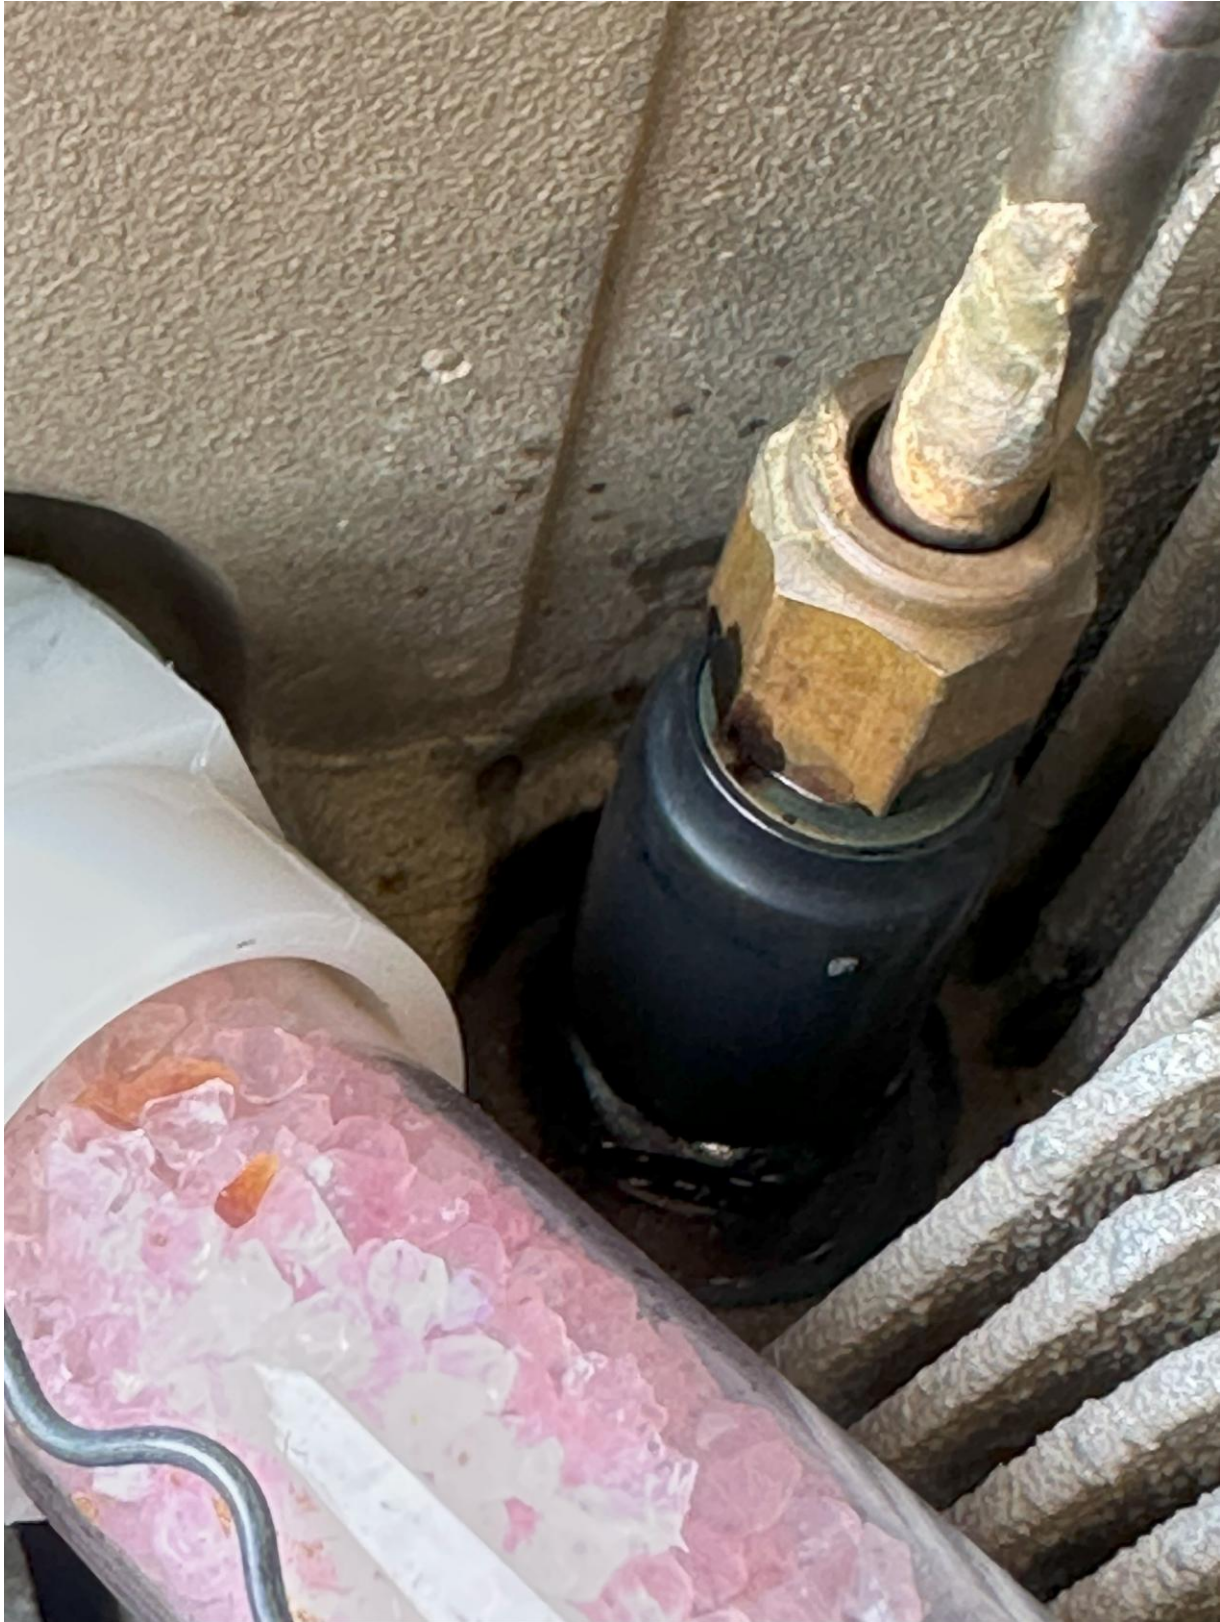
- b. My plane just completed its annual maintenance on March 26, 2025. The fuel injectors all had a hard shiny black substance on them that the shop had never seen before. The substance could not be removed using the normal sonic cleaner and cleaning fluid. They had to use an old-fashioned gun cleaning solvent to remove the material. The unleaded fuel is supposed to burn cleaner than leaded fuel, and there shouldn't be any deposits on the fuel injectors at all. This material could be evidence of chemical decomposition of something in the wetted fuel system.

Here is some black coating on the outside of my fuel injector taken during annual. My mechanic says this coating is not found when 100LL is burned.

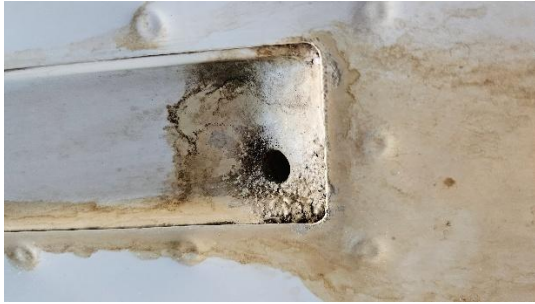
The paint is bubbling immediately adjacent to the fuel vent within the air scoop. Yellow degradation is occurring further away from the vent. This fuel vent is located underneath the wing close to the fuselage. Note that avgas will occasionally drain from the fuel vents. For instance, if the tanks are full and the plane is parked in the sun on a hot day, the fuel will expand and drain out of the fuel vent. Or, if the tanks are full, a little fuel may drain out of the vent when cornering on a taxiway.

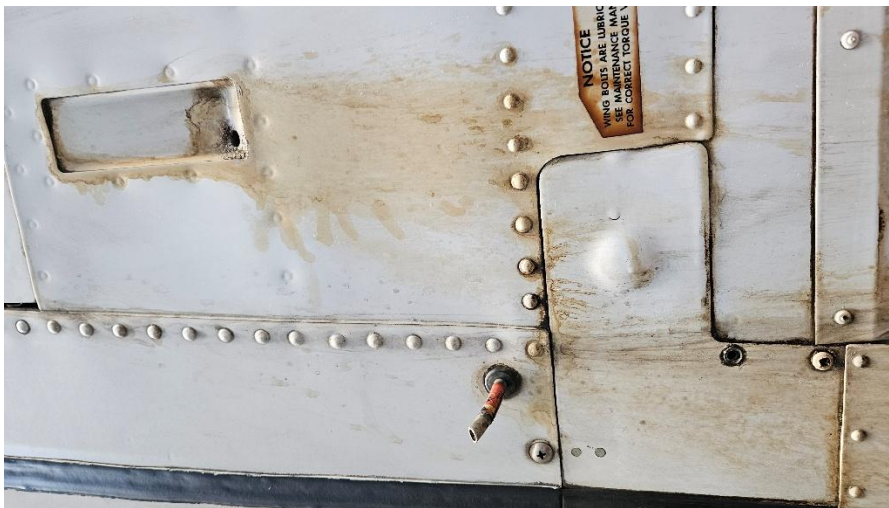
This is the same fuel vent, with the paint degradation clearly shown in the slipstream going aft and moving sideways at the seams in the sheet metal.

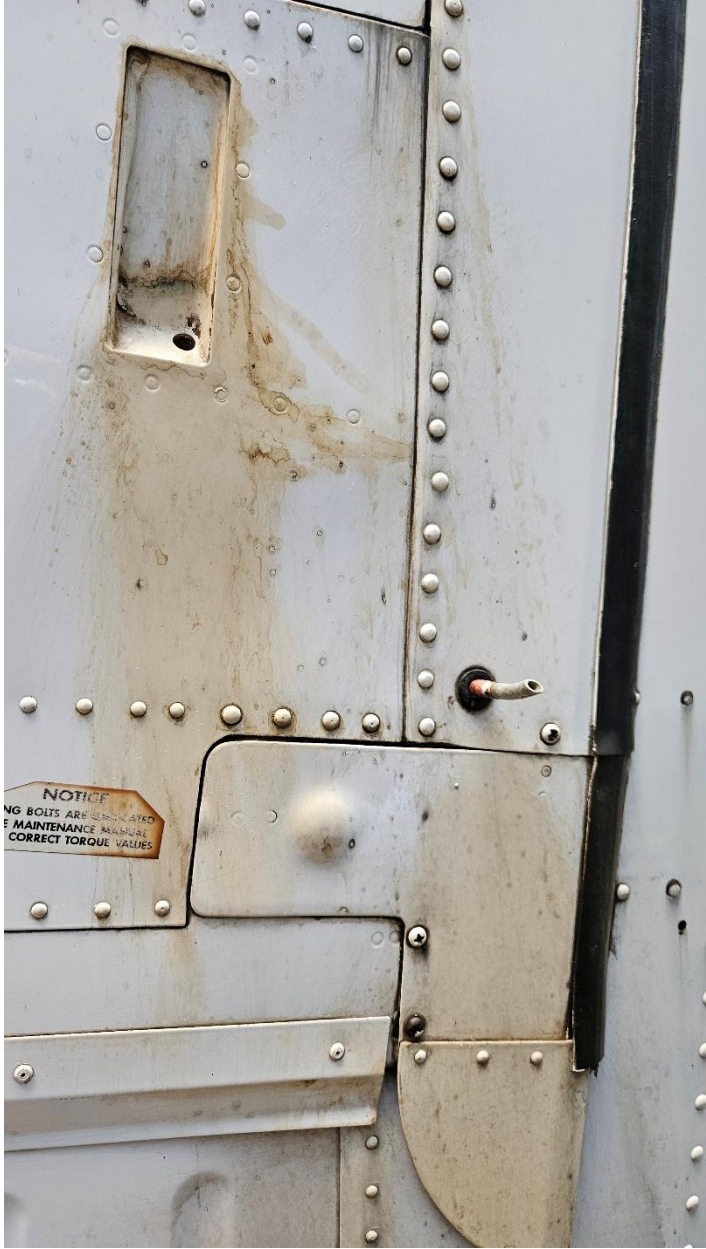
This is the corresponding fuel vent on the other wing. The same degradation pattern is noted.

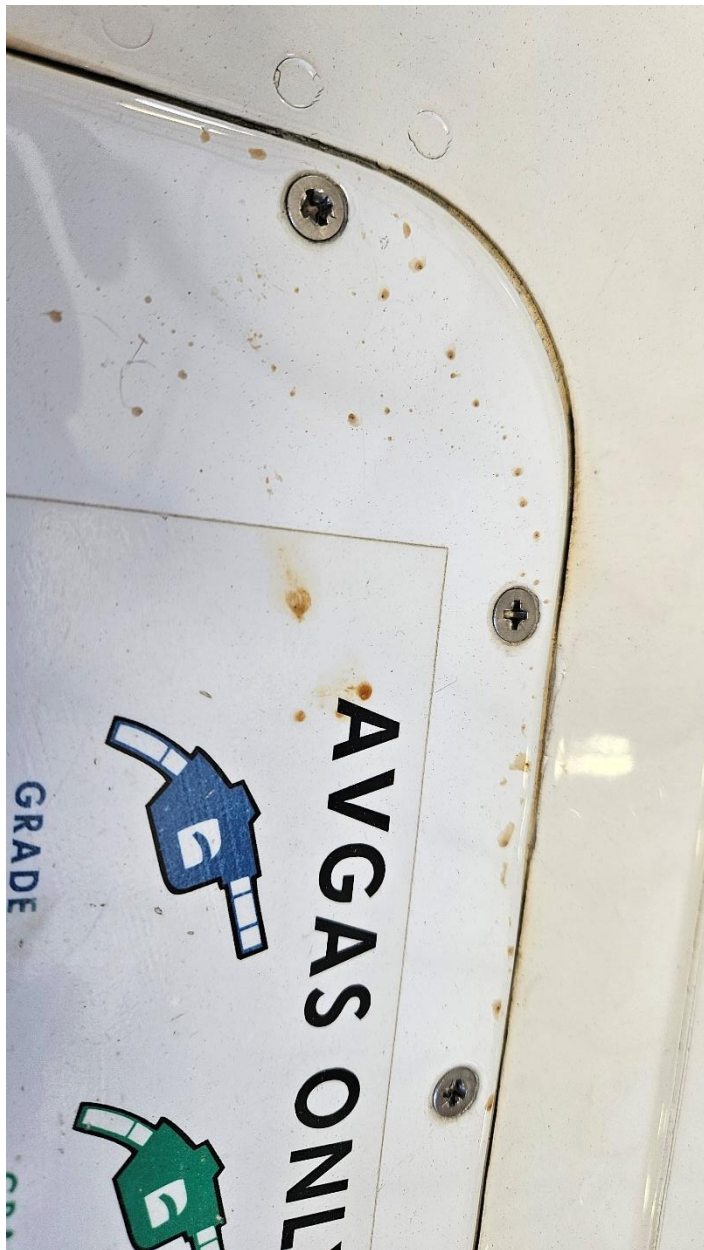
1. The fuel attacks the paint on my plane. The paint is an important source of protection against corrosion for the aluminum in the airframe, and it is inadvisable to use a fuel which degrades this protection. Airplanes last for 75 years or more and corrosion protection makes possible the plane's continued airworthiness. In just four months, the fuel has put brown spots on the paint around the filling ports, attacked the plastic port labels installed by the factory, shriveled a plastic label on the fuel selector valve sump drain cover, bubbled the paint immediately adjacent to a fuel vent under the wing, yellowed large areas of the painted surface of the underwing downstream of two fuel vents, lightly yellowed a grating on the leading edge of my wing, lightly yellowed the paint at the edge of a maintenance panel on the upper wing, barely yellowed the edges of the plates around the main fuel tanks gas caps. See the pictures at the end of this report.

These spots on the wing next to the gas cap have occurred despite my use of custom-made placemats to absorb light splashes of fuel – There are times a fueler will do the fueling (not me) and cause splashing. 100LL fuelers are the worst because they don't realize the damage that will occur if they allow any splashing from the G100UL inside the tank to occur as the refuel with 100LL. The splashes have attacked the paint and the factory fuel decals. These particular spots occurred in Mexico when my protective placemats were accidentally buried under a lot of luggage and I did not monitor the attendants who pumped the fuel. They were pumping 100LL into a tank that was mostly G100UL. I believe there were some minor splashes out of the tank as it became near full and was probably a mixture of something like 30% G100UL and 70% 100LL. I didn't monitor the attendants – I may have been busy dealing with customs, immigration, airport commandant, or flight plan office at the time.

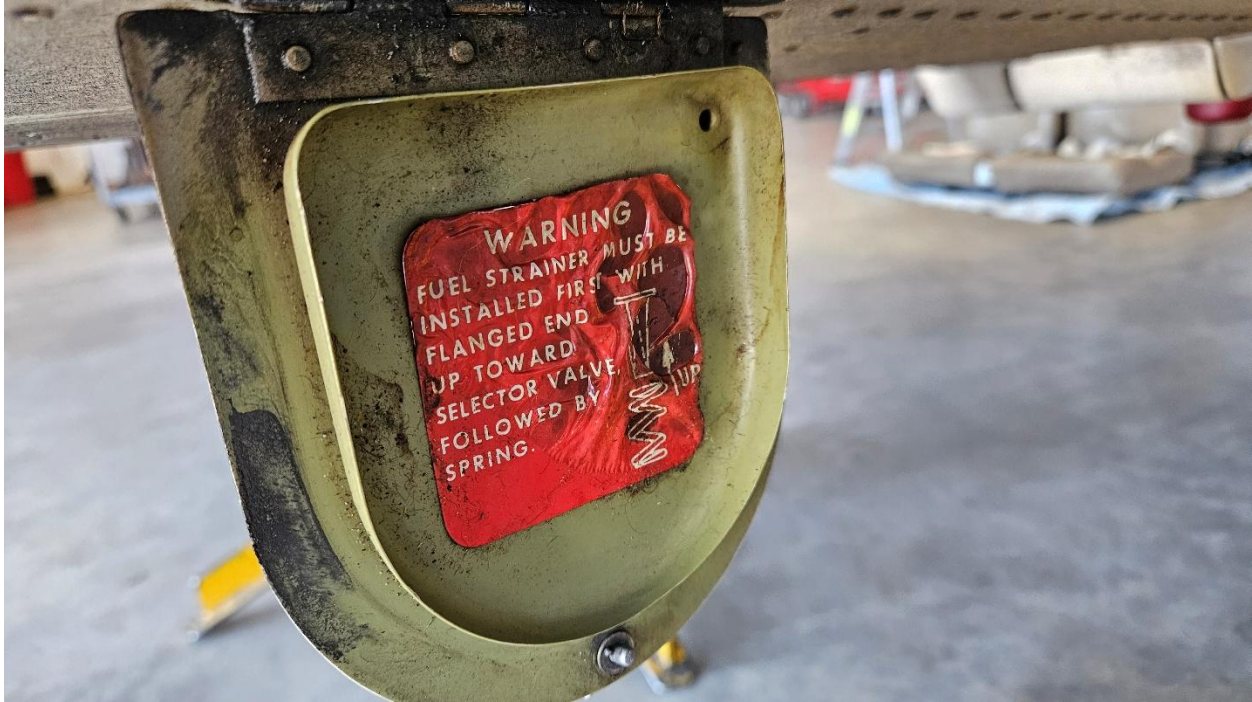
This is the access port for the fuel sampling valve under the fuel selector switch. The fuel has attacked the factory label that provides safety instructions for installing the hardware.

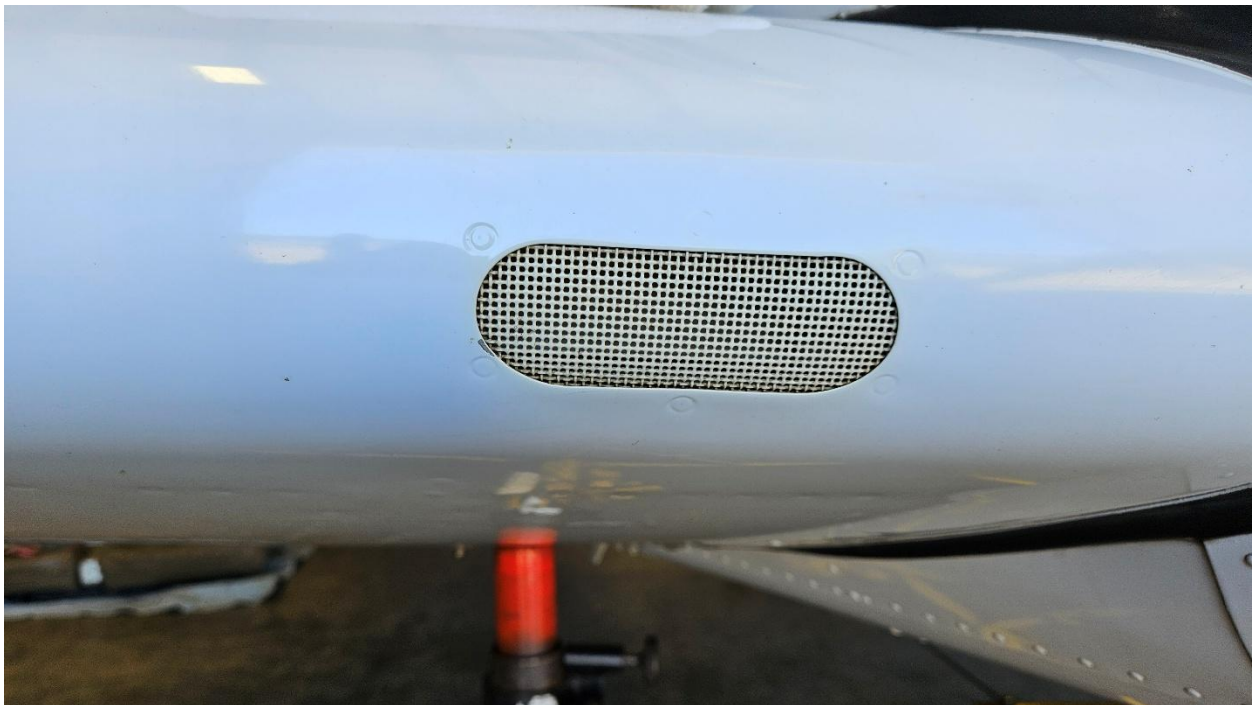
This screen on the leading edge has some of the yellow staining associated with G100UL exposure. The mechanic is uncertain how it would get here, other than somehow the gas tank might be venting into the wing and providing fumes that discolor the paint.

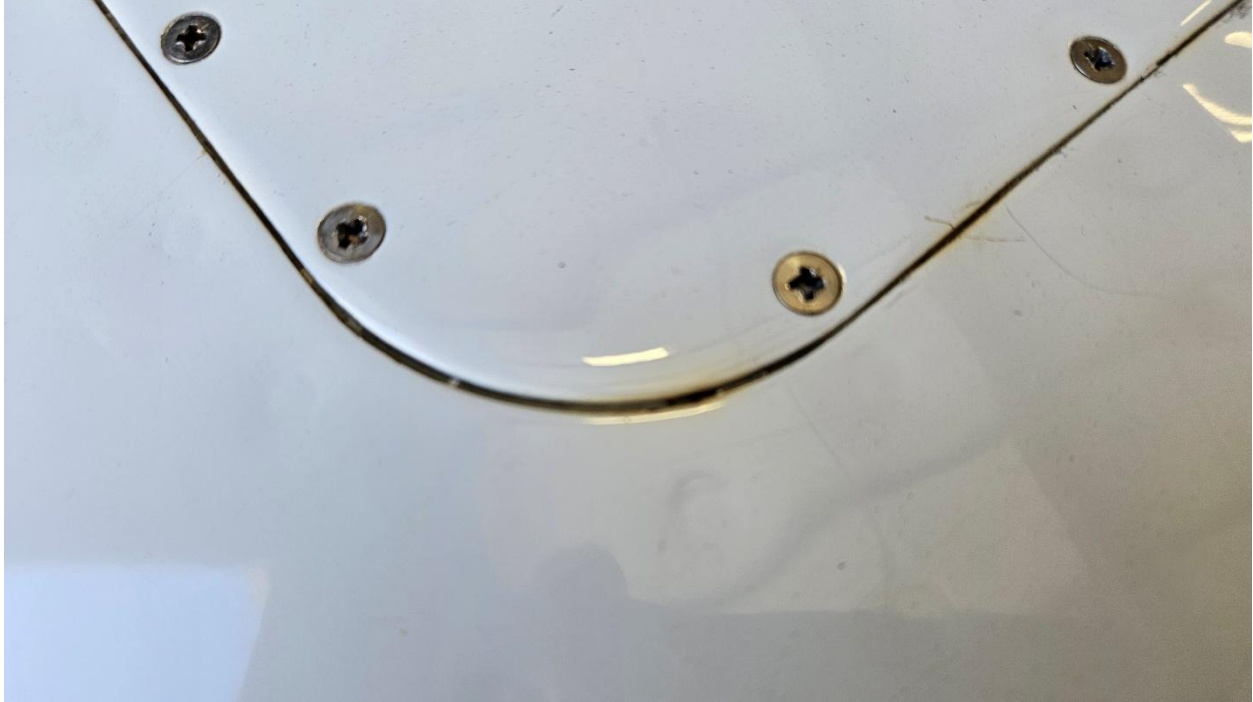
This access port has faint yellow staining on the corner. This is not a likely place for fuel contamination and is somewhat of a puzzle as to how the contamination took place.

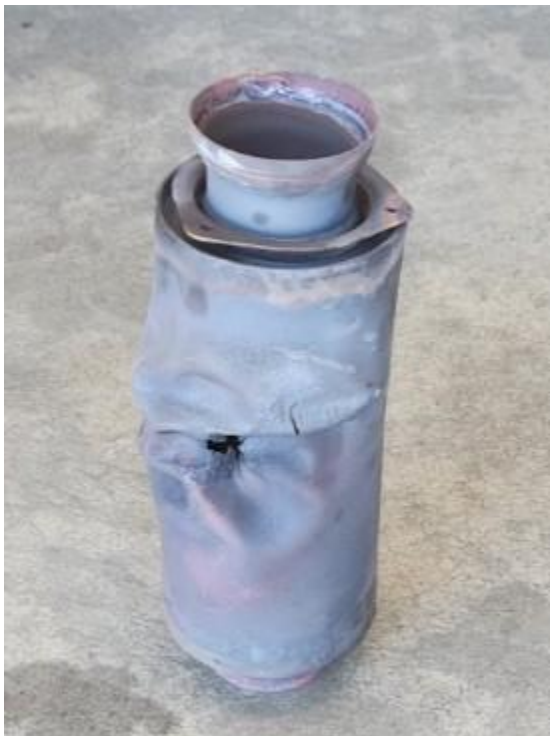
3. At my annual just being completed, my left muffler had to be replaced due to heat damage. See the picture at the end of the report. It is not clear why this heat damage occurred. The mechanics do not often see this. The damage was on the outside of the muffler, and the individual shock wave cones were fine. Is there some leaning behavior that occurs differently with G100UL than with 100LL, this difference causing heat damage to the muffler? Or was it some other cause? There were at least a couple of backfires on startup during the year since the previous annual. I don't believe we will find the root cause of this damage, but I mention it now in case it is also found in other planes using G100UL fuel. The right muffler was fine. We noted that the G100UL seems to fire more quickly in the engine than the 100LL does, and perhaps that is somehow related.

This is my left side muffler which had to be replaced at this annual maintenance cycle. We are unsure how this damage occurred. Fortunately there is a heat barrier that is installed outside the muffler which did its job in protecting other wiring and assemblies in the engine compartment. There were one or two backfires on start up since the previous annual.
