G100UL Usage Report

Bonanza A36, N4305U, manufactured 2000, s/n E-3305

2025 04 02, version 6

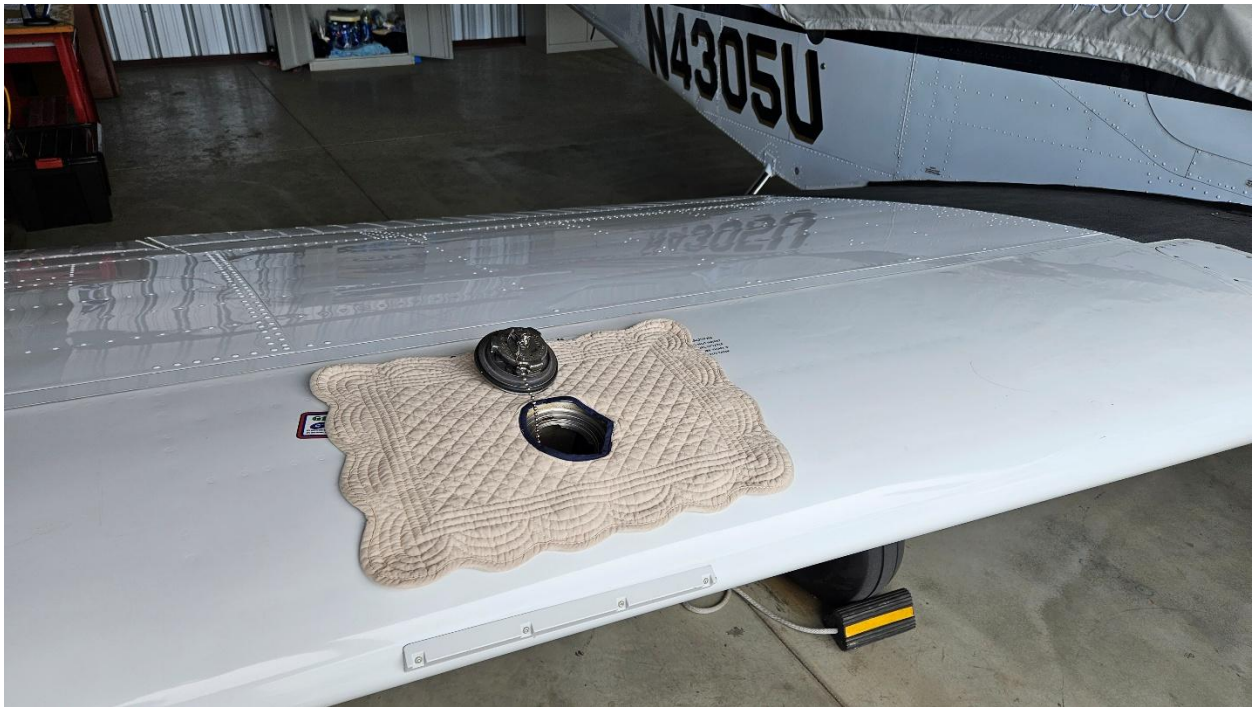
Here is a picture of the place mat that I modified to serve as a protective barrier for minor splashing while refueling. It was highly effective when used.

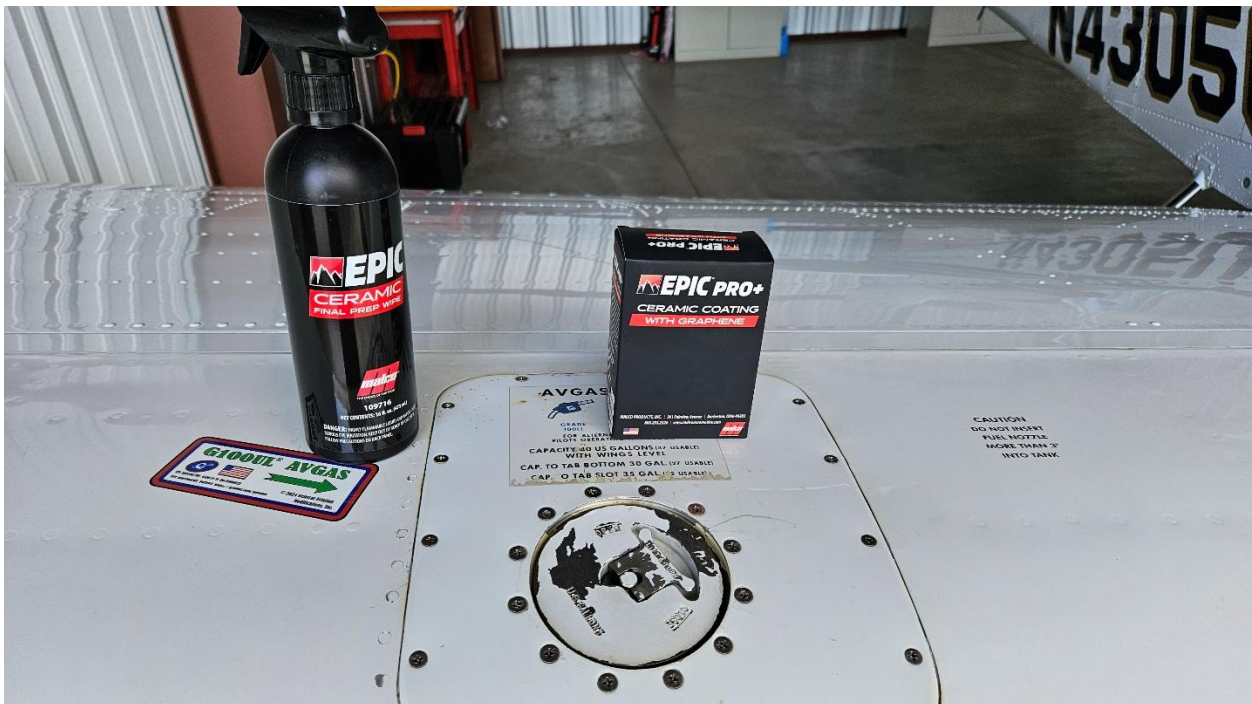
Here are the ceramic coating products that I put on the wing to improve its ability to withstand accidental splashing with fuel. I coated about a 3' x 4' area around the gas cap. I probably didn't do it as well as professional would.
